# Guam Waterworks Authority (VP0989)

## CWA Collection System

Tumon, Guam

NEIC Field Investigation Photographs  
April 24 through May 4

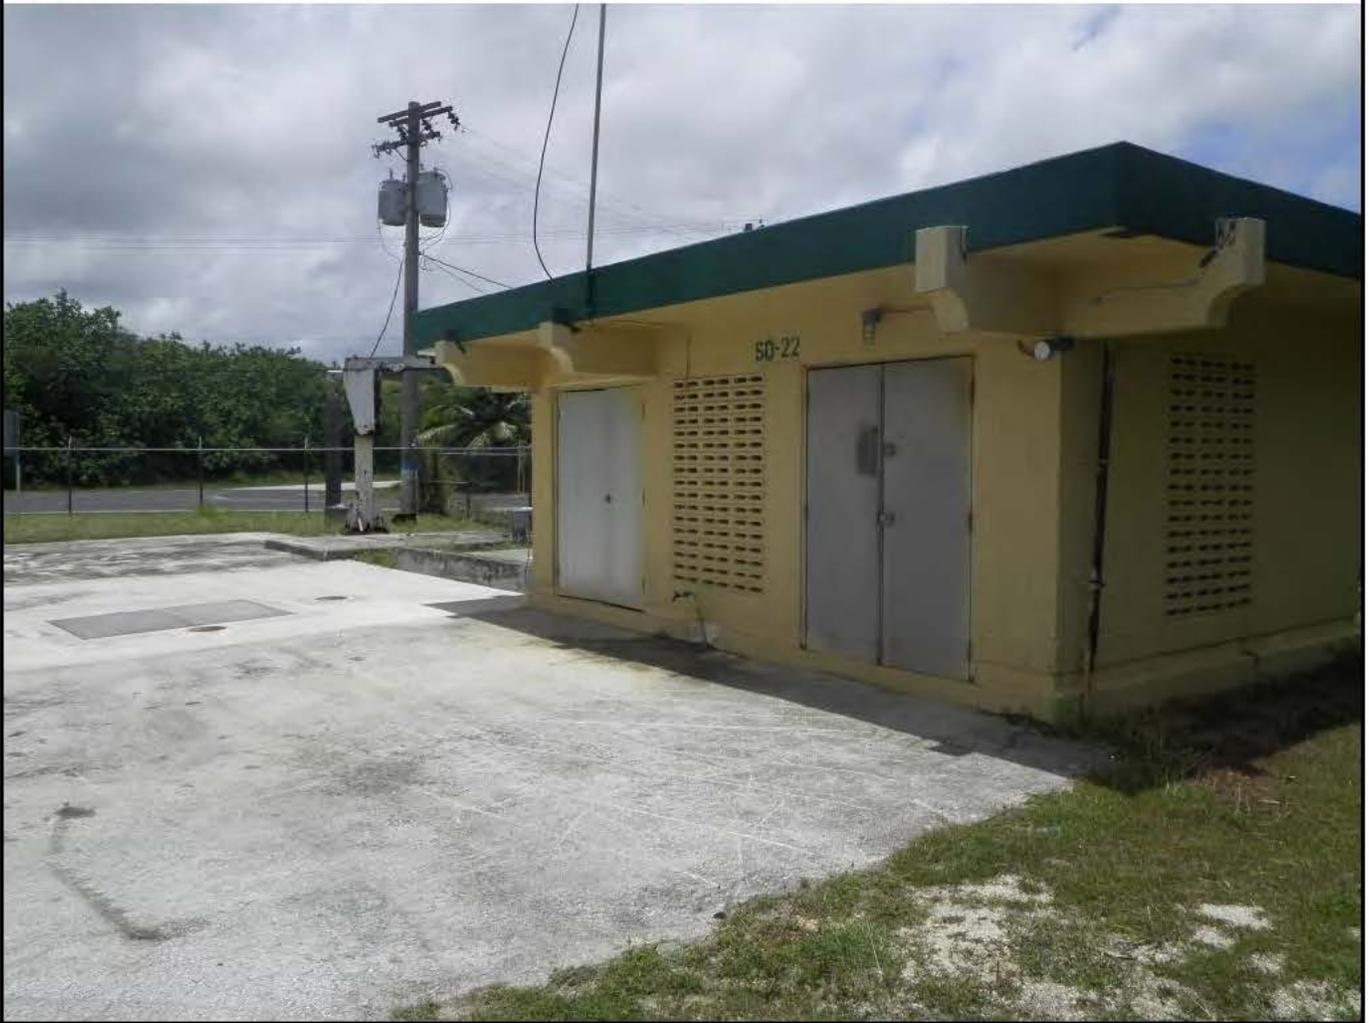
File Name: RIMG0039.JPG

<b>Title</b>	Guam Waterworks Authority (VP0989)
<b>Subject</b>	CWA Collection System
<b>Date Time Stamp</b>	4/26/2012 12:24:48 PM
<b>Photographer</b>	D. Vanlerberghe
<b>Description</b>	Inarajan main pump station building

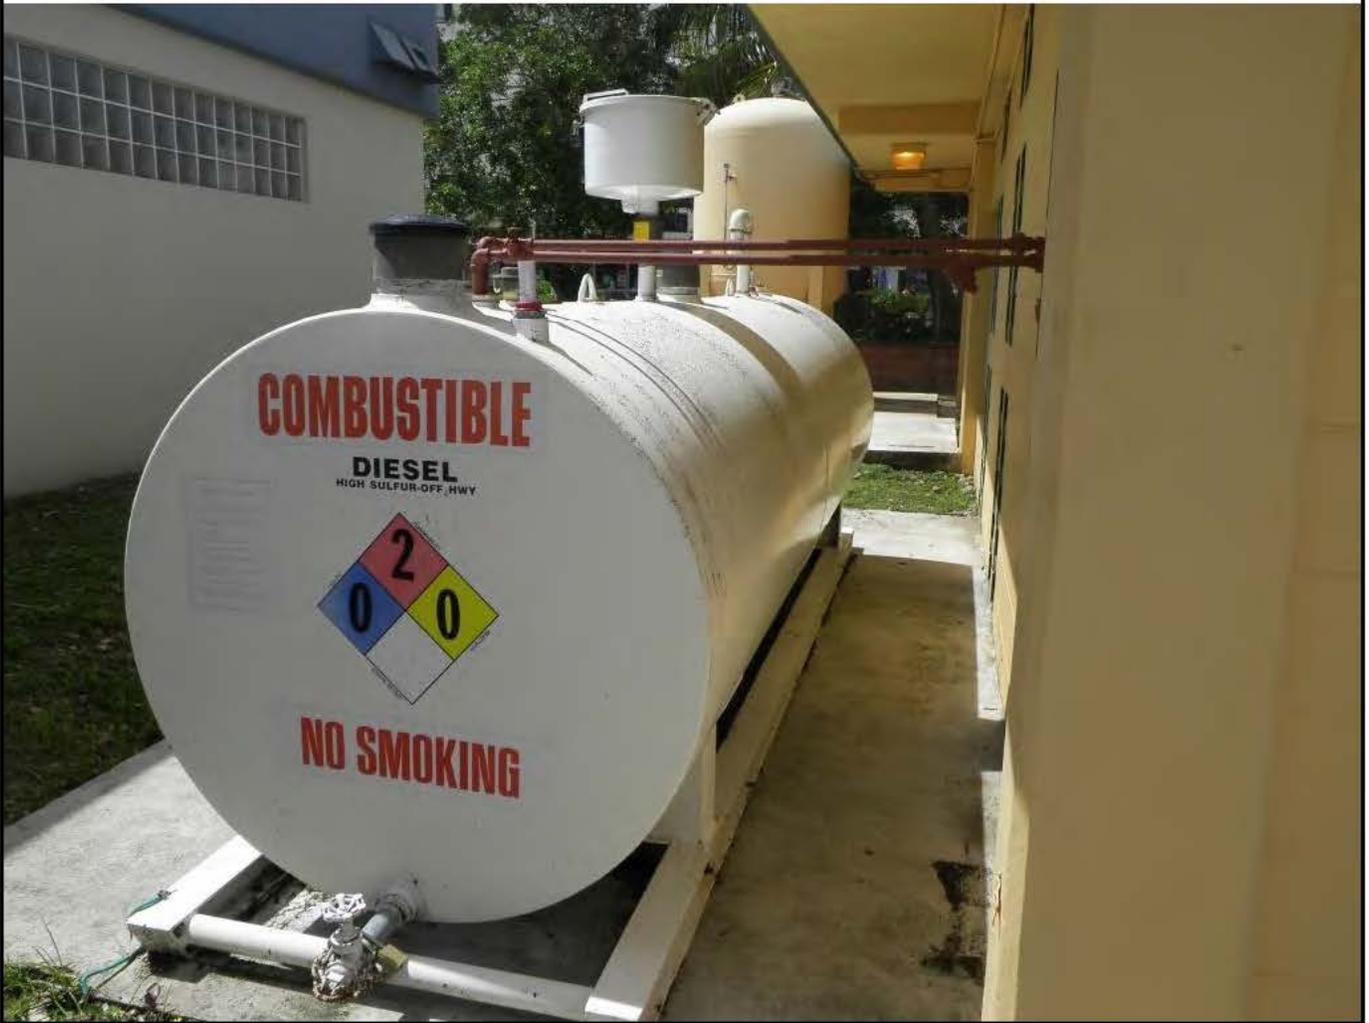
File Name: RIMG0040.JPG

Title	Guam Waterworks Authority (VP0989)
Subject	CWA Collection System
Date Time Stamp	4/27/2012 10:09:43 AM
Photographer	D. Vanlerberghe
Description	Fujita pump station, showing diesel fuel tank and surge control tank in background

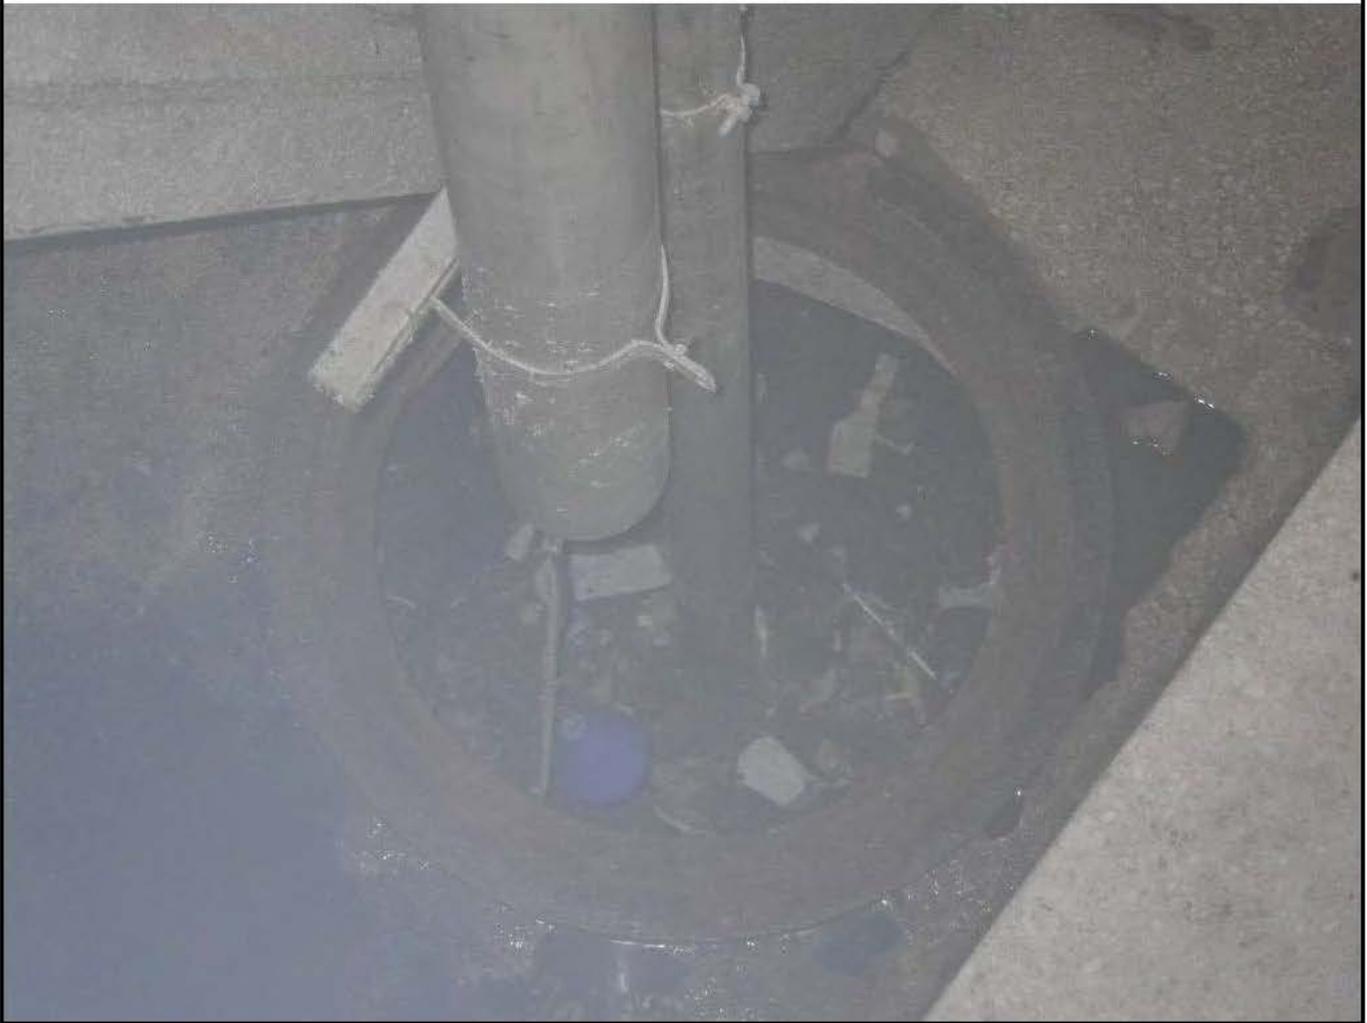
File Name: RIMG0043.JPG

<b>Title</b>	Guam Waterworks Authority (VP0989)
<b>Subject</b>	CWA Collection System
[REDACTED]	[REDACTED]
[REDACTED]	[REDACTED]
<b>Date Time Stamp</b>	4/27/2012 10:12:00 AM
<b>Photographer</b>	D. Vanlerberghe
<b>Description</b>	Fujita pump station wet well, showing level sensor and float

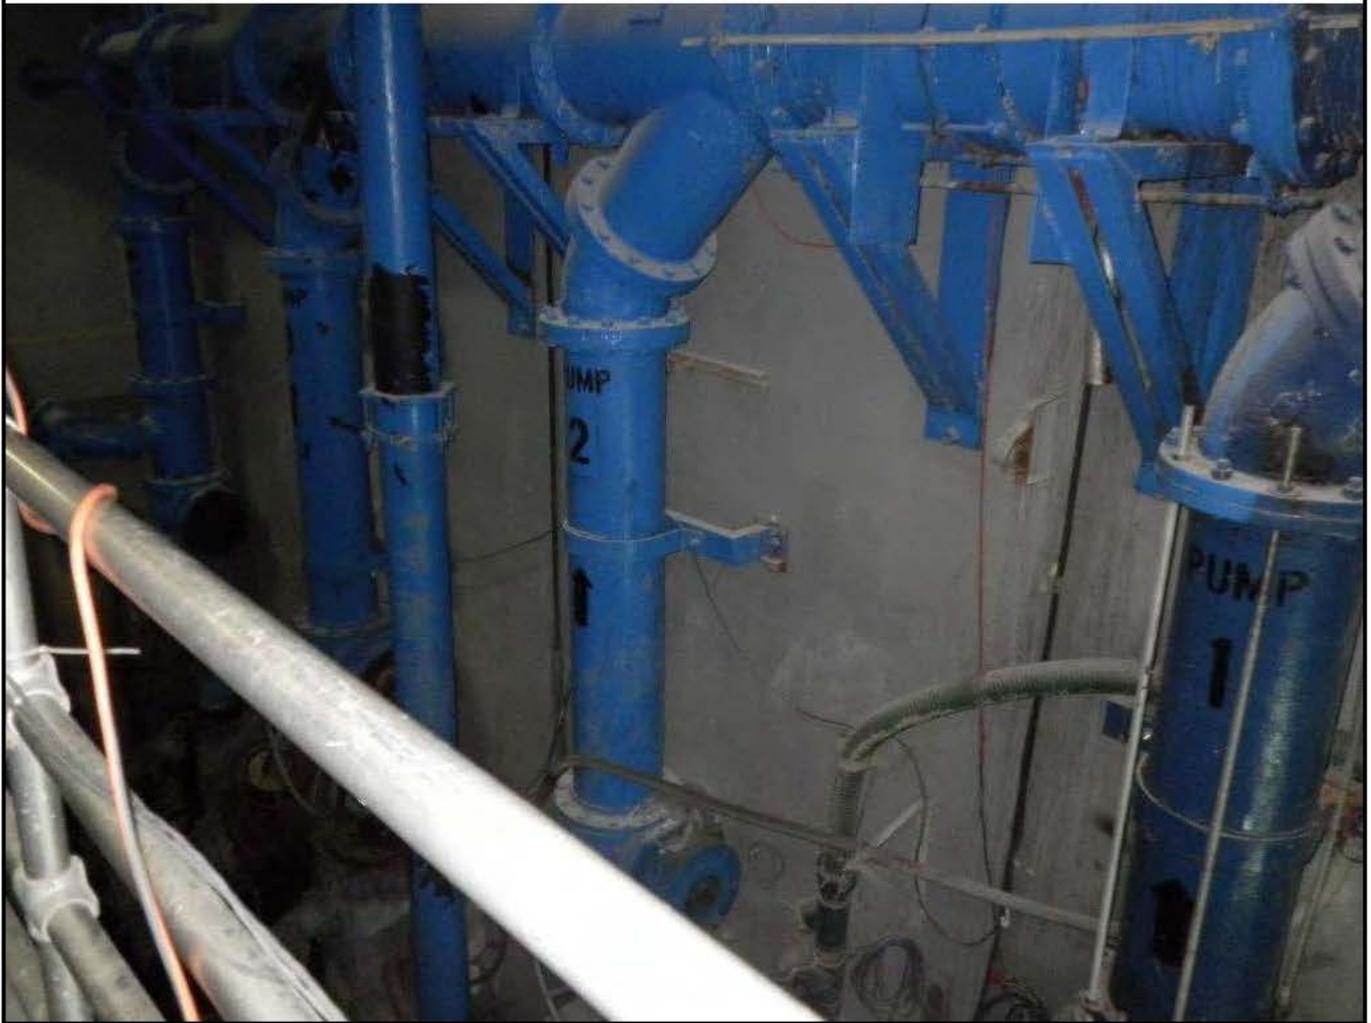
File Name: RIMG0045.JPG

Title	Guam Waterworks Authority (VP0989)
Subject	CWA Collection System
[REDACTED]	[REDACTED]
[REDACTED]	[REDACTED]
Date Time Stamp	4/27/2012 10:15:56 AM
Photographer	D. Vanlerberghe
Description	Fujita pump station pumps

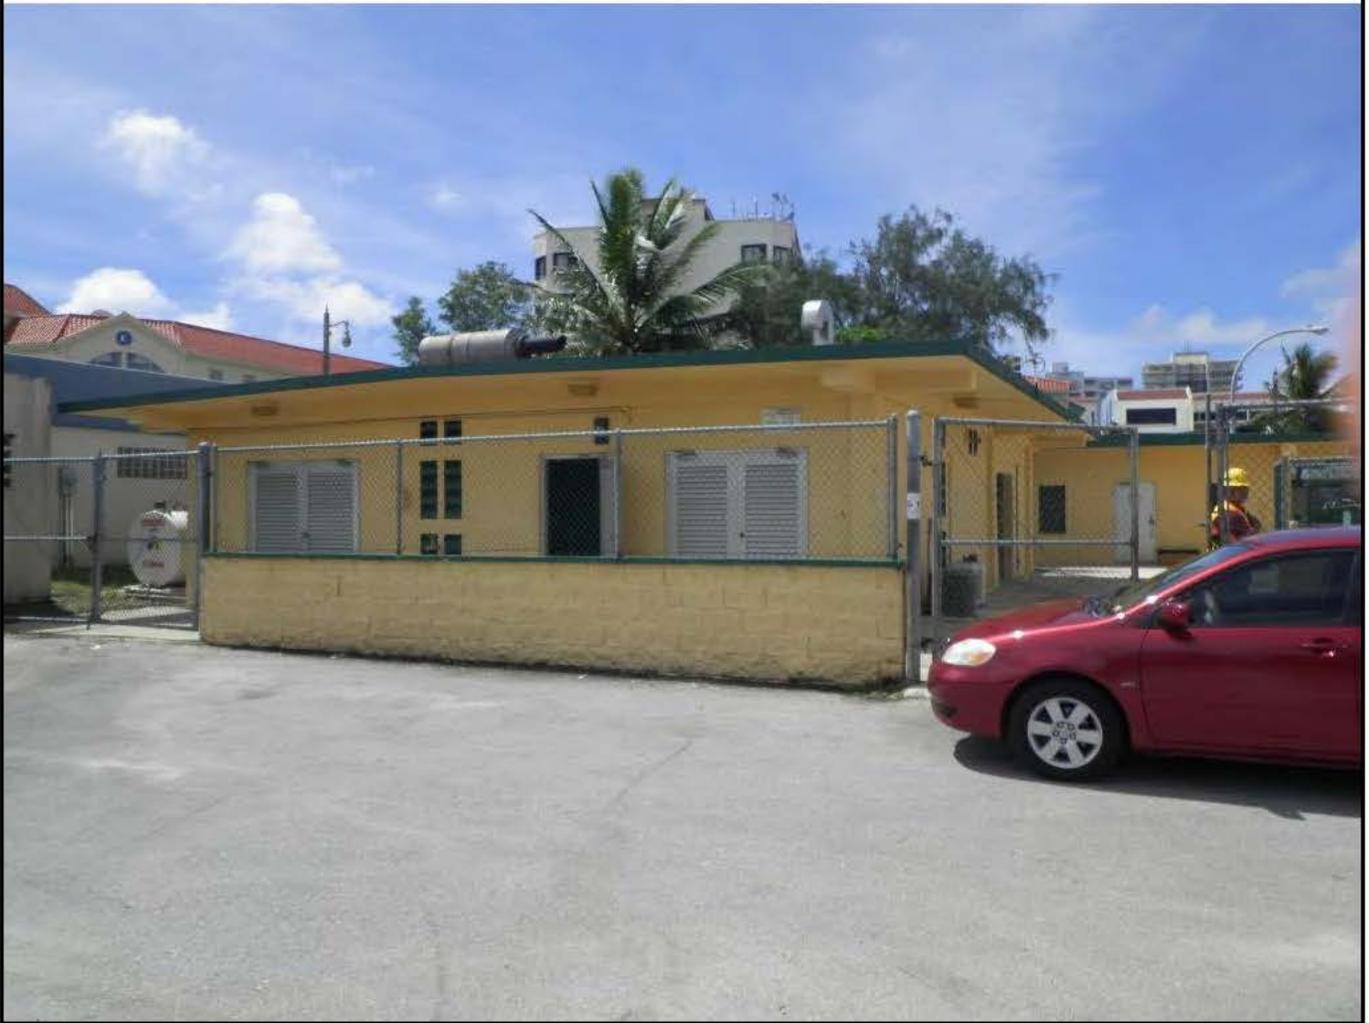
File Name: RIMG0046.JPG

Title	Guam Waterworks Authority (VP0989)
Subject	CWA Collection System
[REDACTED]	[REDACTED]
[REDACTED]	[REDACTED]
Date Time Stamp	4/27/2012 10:24:23 AM
Photographer	D. Vanlerberghe
Description	Fujita pump station building

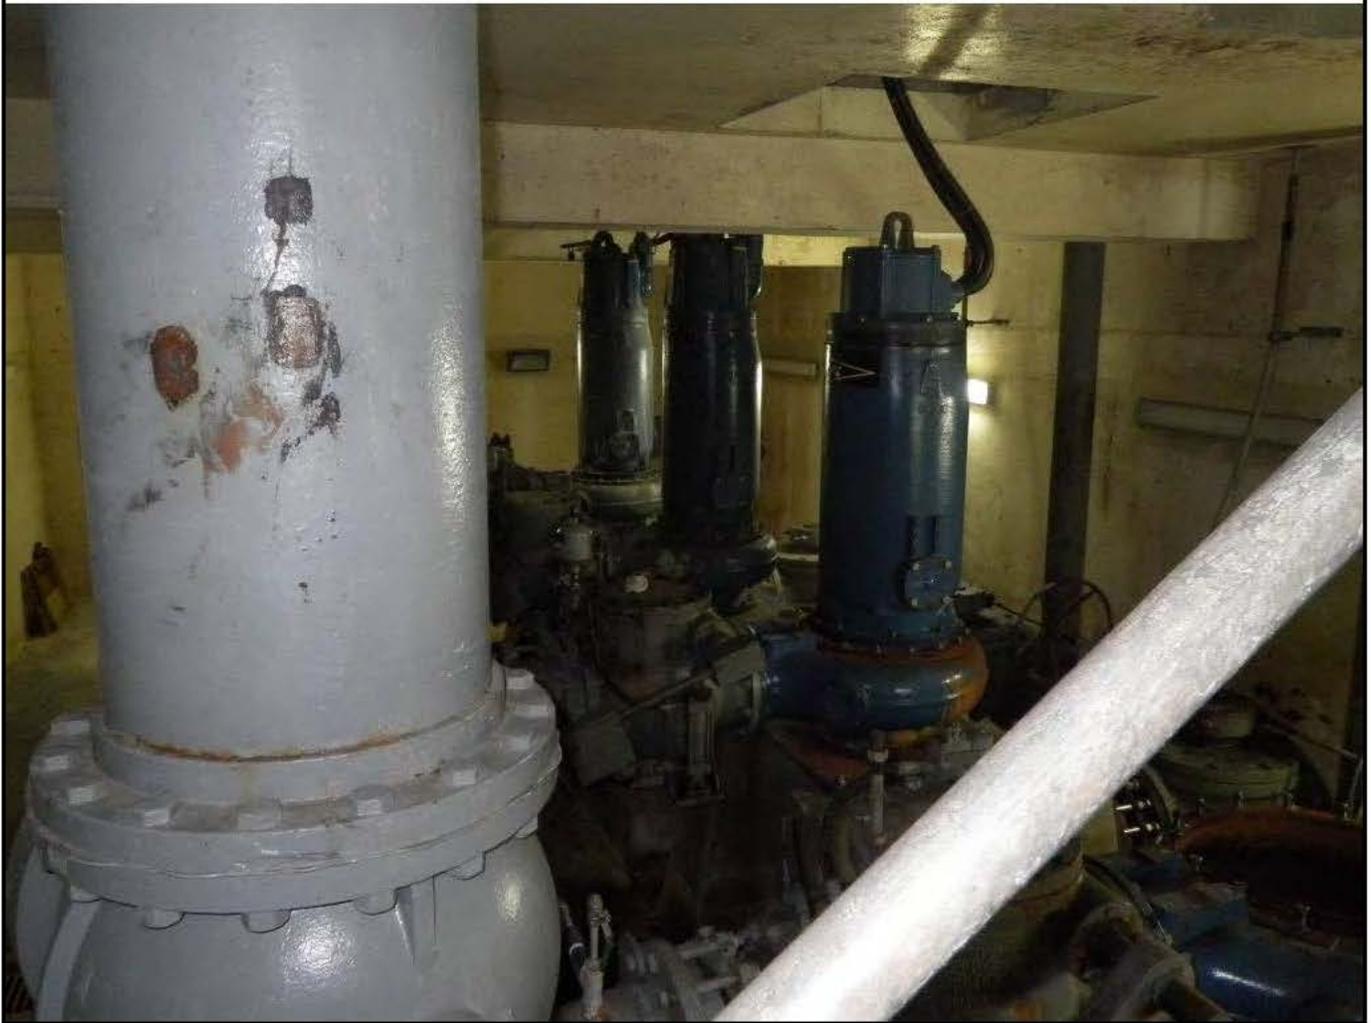
File Name: RIMG0048.JPG

Title	Guam Waterworks Authority (VP0989)
Subject	CWA Collection System
Date Time Stamp	4/27/2012 10:54:48 AM
Photographer	D. Vanlerberghe
Description	Route 16 pump station pumps

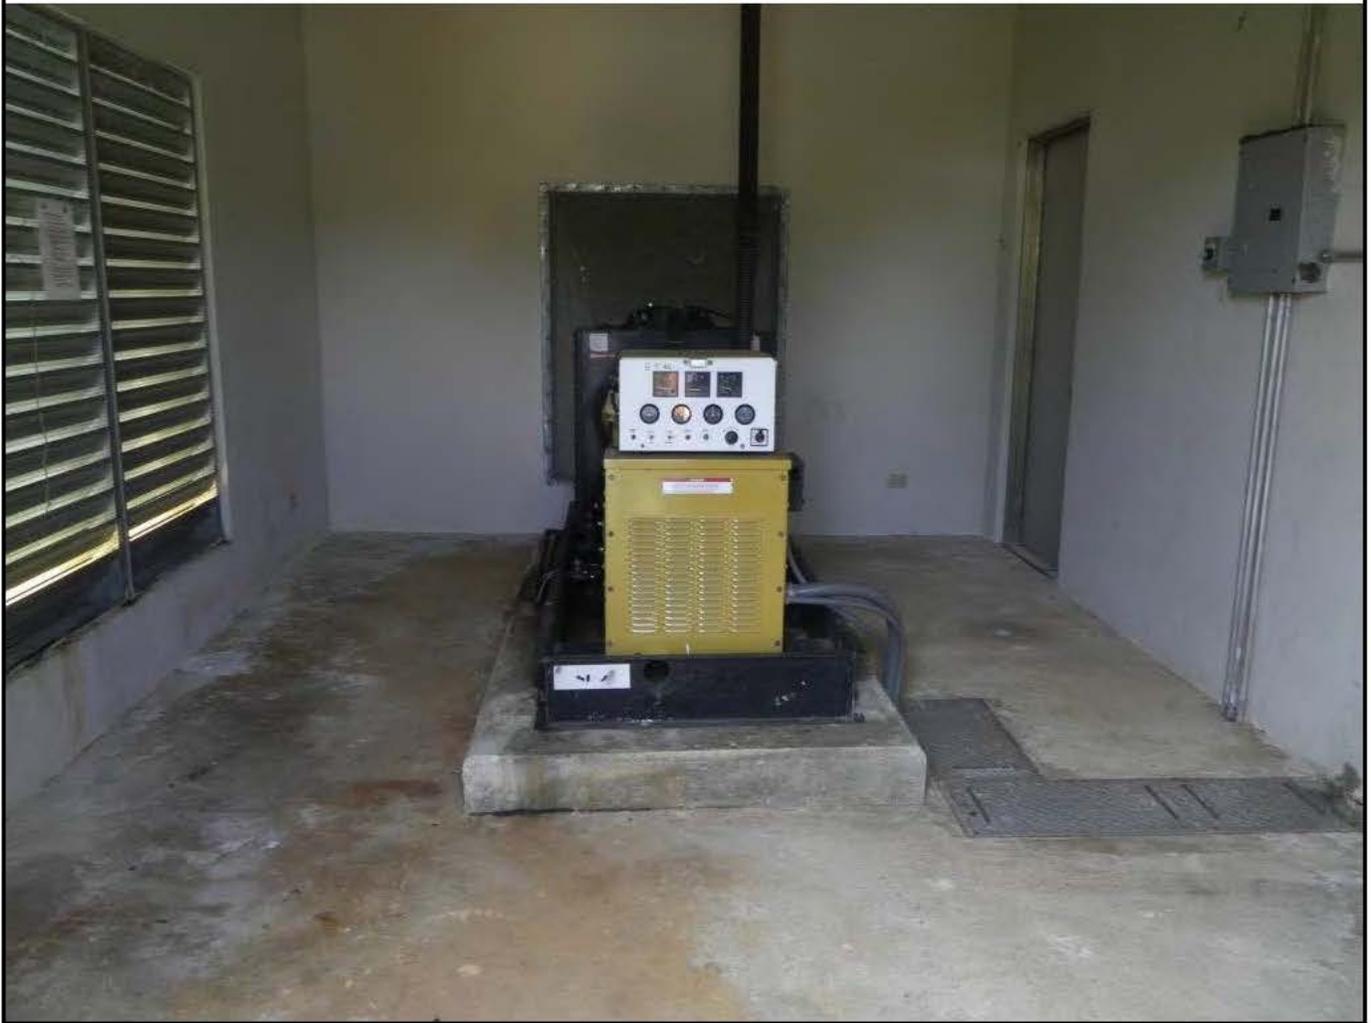
File Name: RIMG0051.JPG

Title	Guam Waterworks Authority (VP0989)
Subject	CWA Collection System
Date Time Stamp	4/27/2012 1:34:25 PM
Photographer	D. Vanlerberghe
Description	Double Trouble pump station standby generator

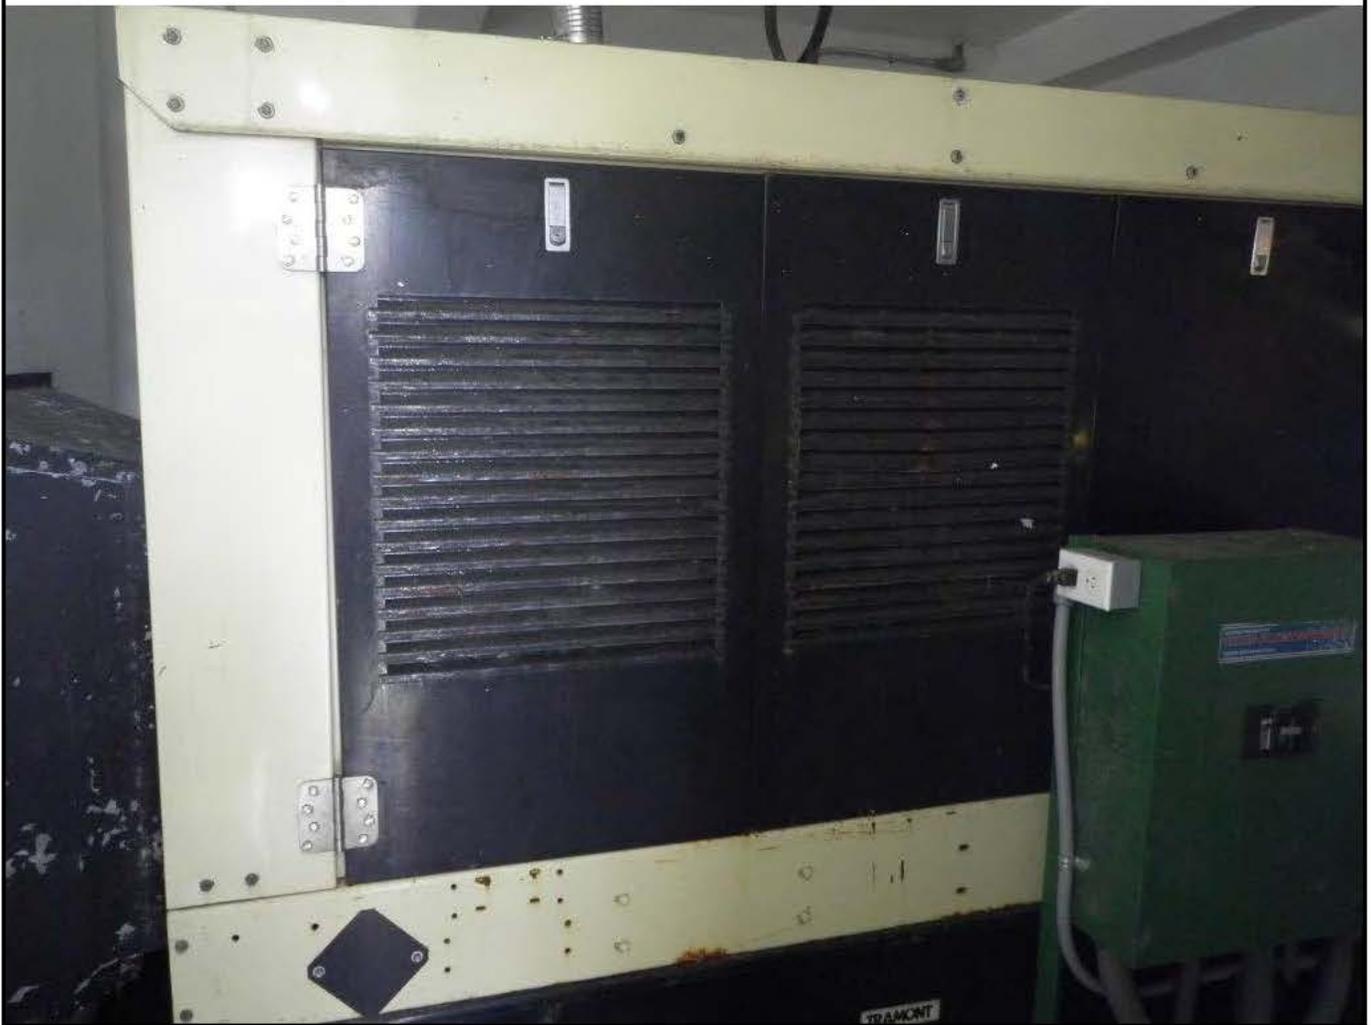
File Name: RIMG0055.JPG

Title	Guam Waterworks Authority (VP0989)
Subject	CWA Collection System
Date Time Stamp	4/27/2012 1:53:54 PM
Photographer	D. Vanlerberghe
Description	PGD pump station standby generator

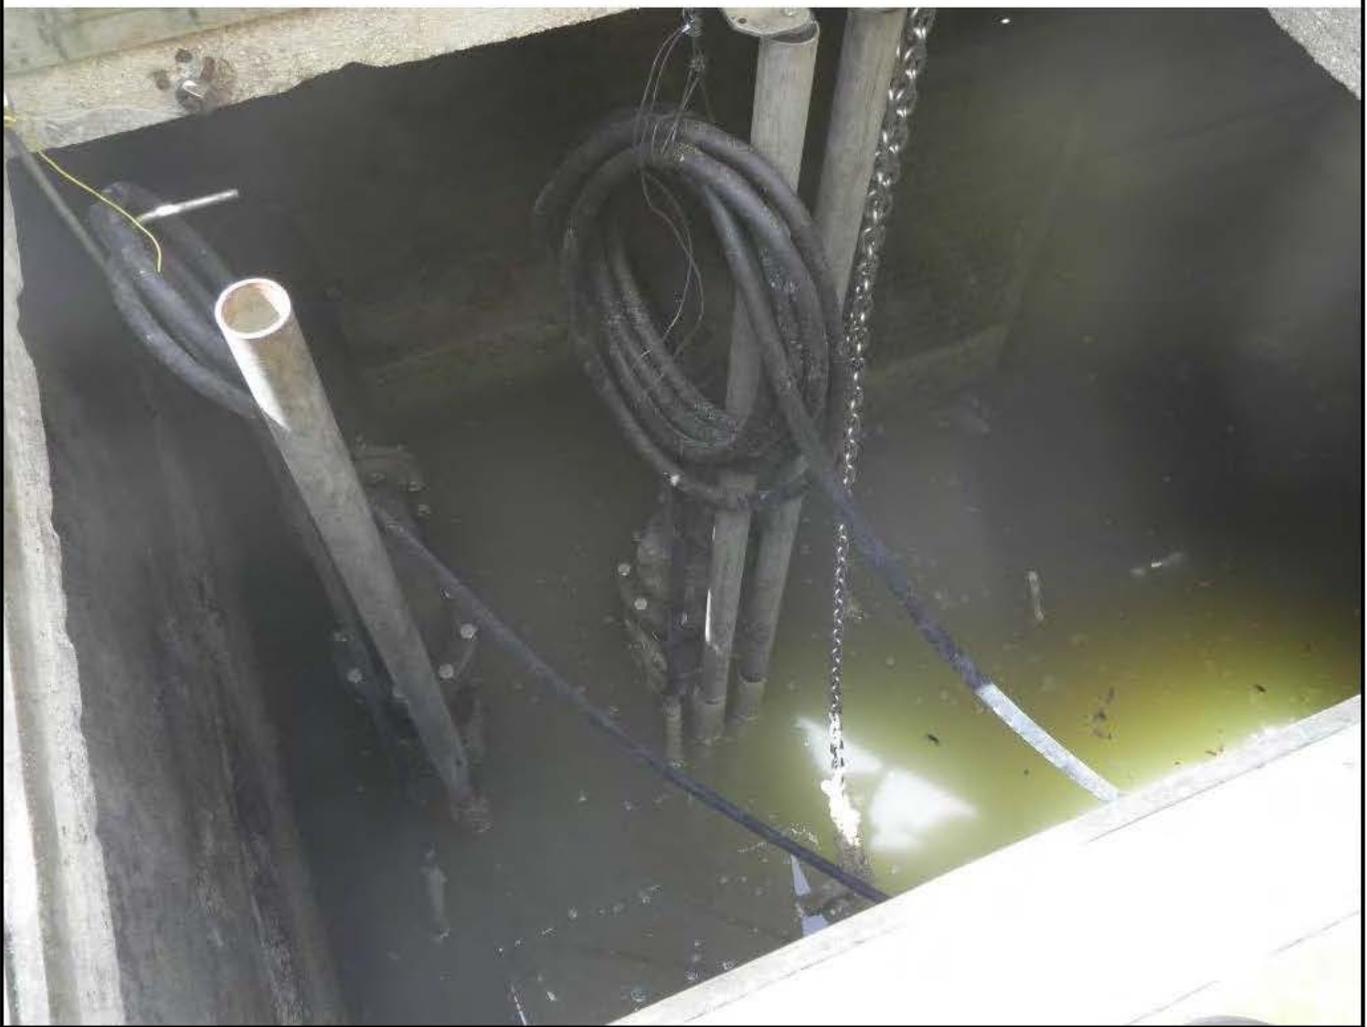
File Name: RIMG0056.JPG

Title	Guam Waterworks Authority (VP0989)
Subject	CWA Collection System
Date Time Stamp	4/27/2012 2:00:21 PM
Photographer	D. Vanlerberghe
Description	PGD pump station wet well

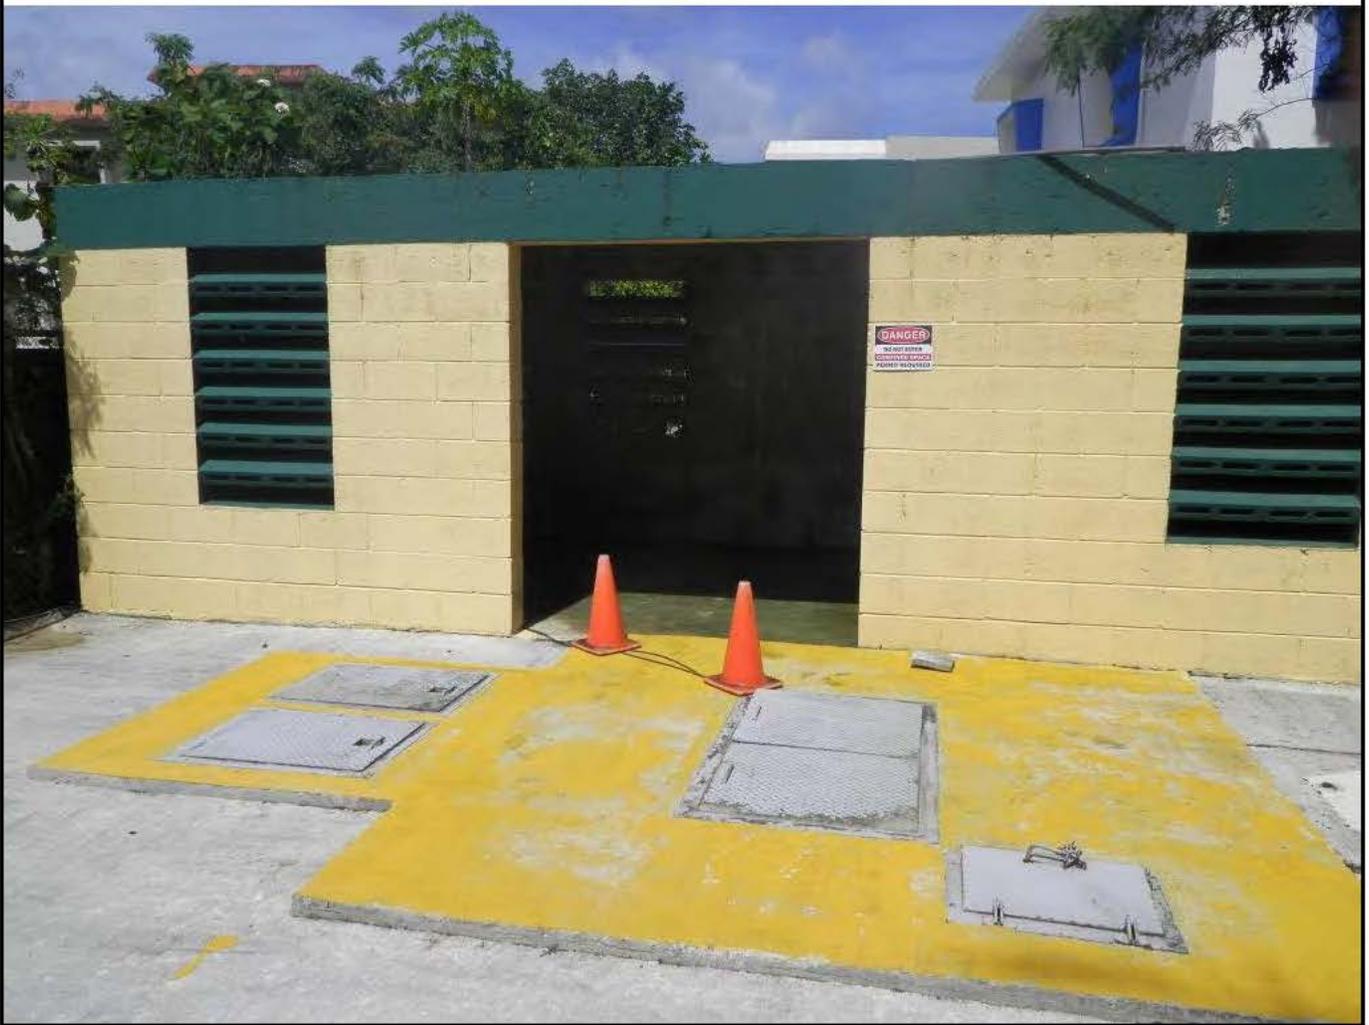
File Name: RIMG0060.JPG

Title	Guam Waterworks Authority (VP0989)
Subject	CWA Collection System
Date Time Stamp	4/27/2012 2:23:03 PM
Photographer	D. Vanlerberghe
Description	Hafa Adai pump station building

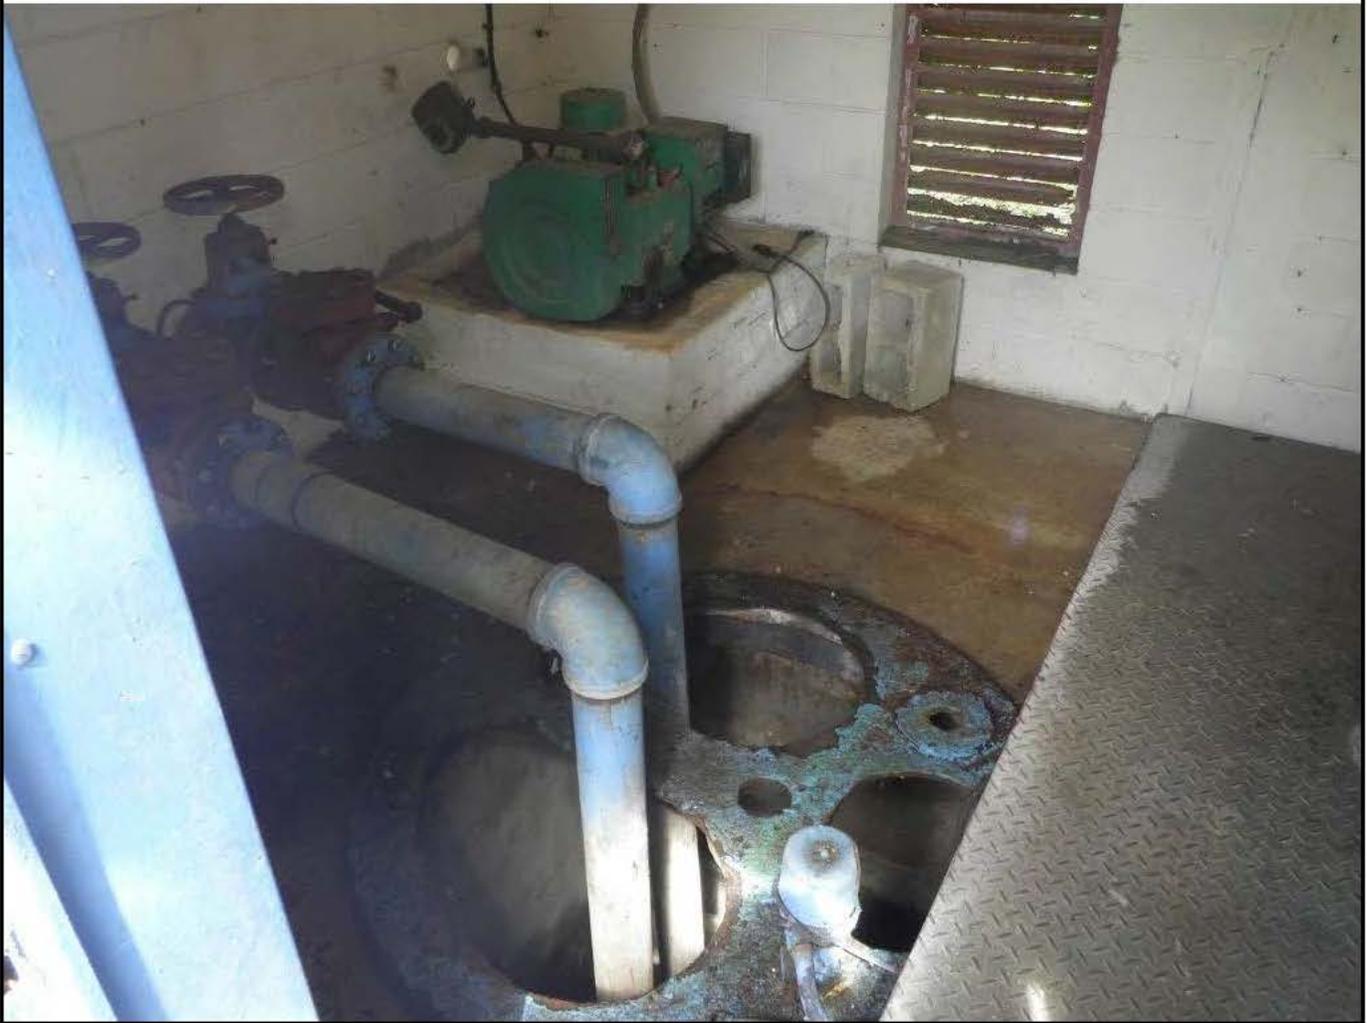
File Name: RIMG0061.JPG

Title	Guam Waterworks Authority (VP0989)
Subject	CWA Collection System
Date Time Stamp	4/27/2012 2:50:53 PM
Photographer	D. Vanlerberghe
Description	Santa Ana pump station wet well and out-of-service standby generator

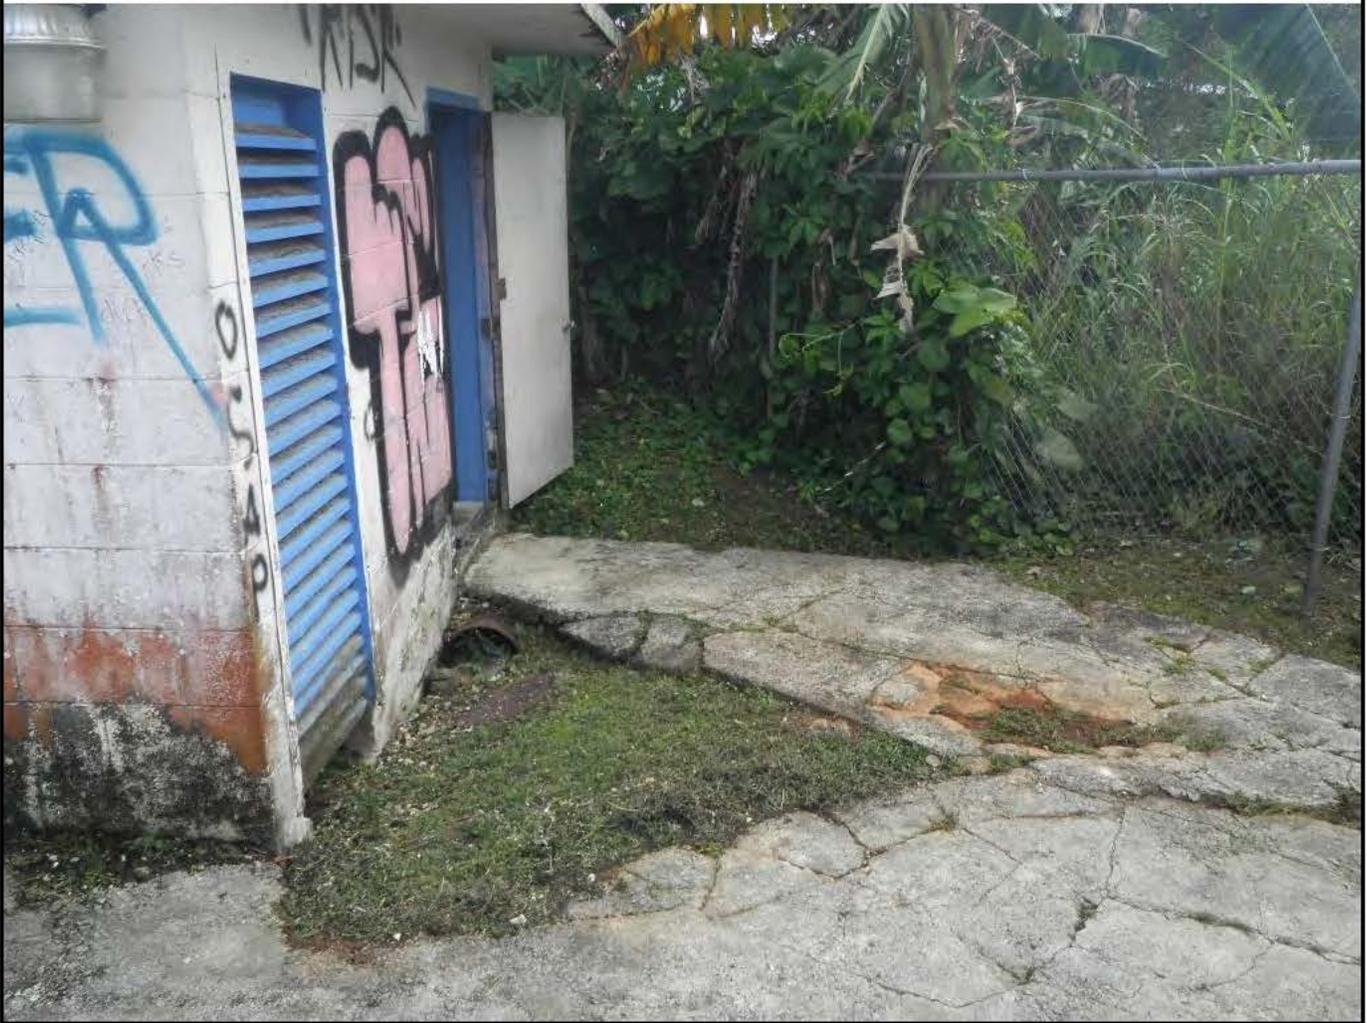
File Name: RIMG0062.JPG

<b>Title</b>	Guam Waterworks Authority (VP0989)
<b>Subject</b>	CWA Collection System
[REDACTED]	[REDACTED]
[REDACTED]	[REDACTED]
<b>Date Time Stamp</b>	4/27/2012 2:55:11 PM
<b>Photographer</b>	D. Vanlerberghe
<b>Description</b>	Santa Ana pump station building, showing adjacent ponding basin area. Overflows from the wet well would flows outside of building and into the adjacent ponding basin, according to GWA staff.

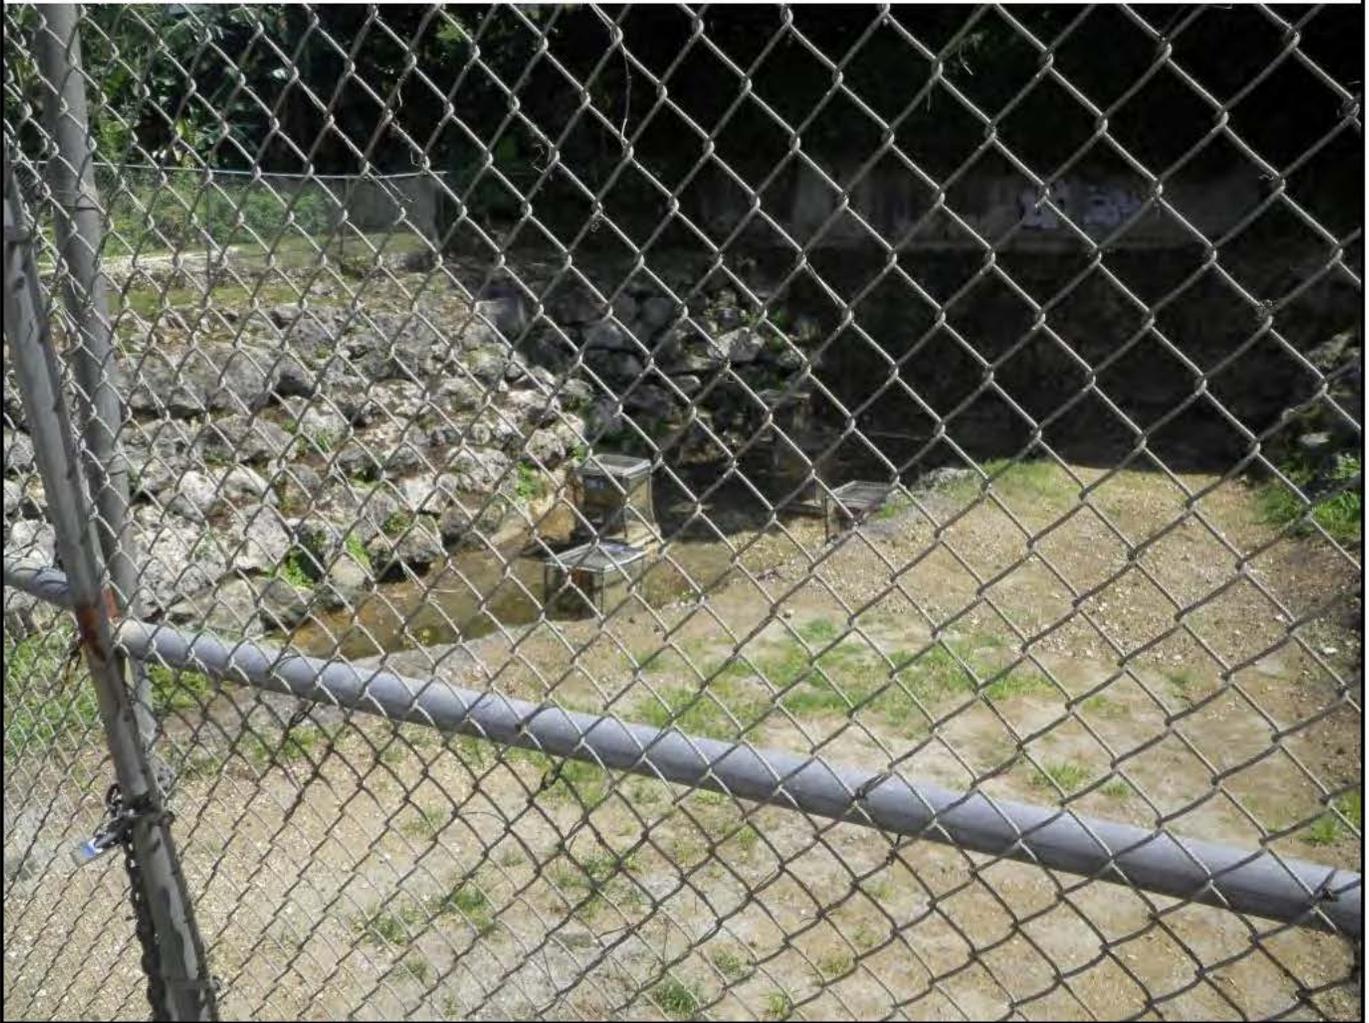
File Name: RIMG0064.JPG

<b>Title</b>	Guam Waterworks Authority (VP0989)
<b>Subject</b>	CWA Collection System
<b>Date Time Stamp</b>	4/30/2012 9:55:15 AM
<b>Photographer</b>	D. Vanlerberghe
<b>Description</b>	Agana Heights ponding basin

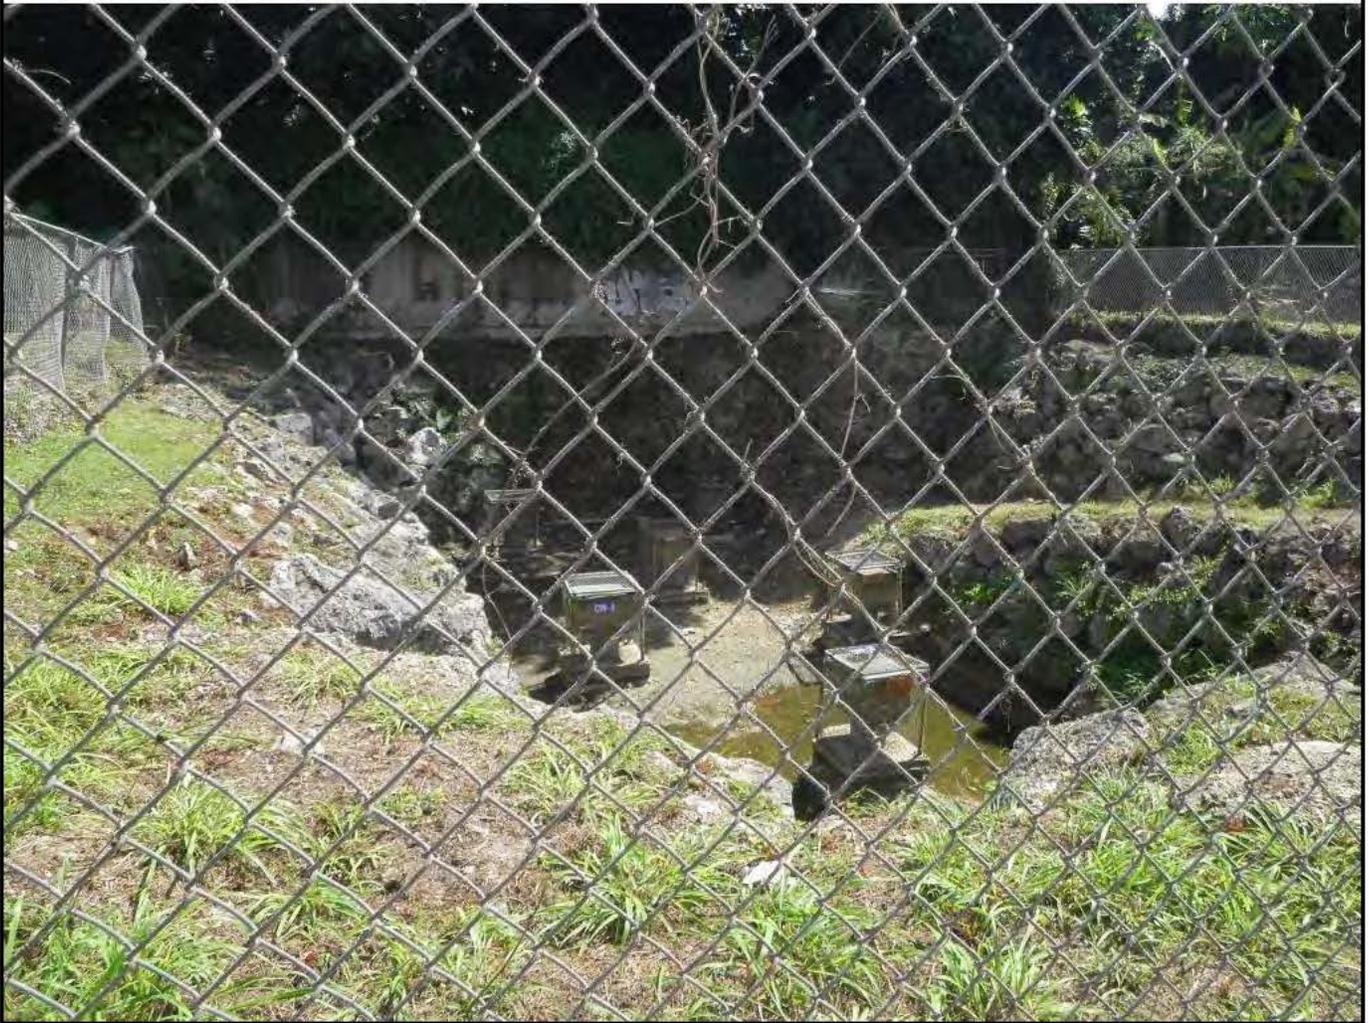
File Name: RIMG0065.JPG

<b>Title</b>	Guam Waterworks Authority (VP0989)
<b>Subject</b>	CWA Collection System
[REDACTED]	[REDACTED]
[REDACTED]	[REDACTED]
<b>Date Time Stamp</b>	4/30/2012 9:56:57 AM
<b>Photographer</b>	D. Vanlerberghe
<b>Description</b>	Agana Heights ponding basin

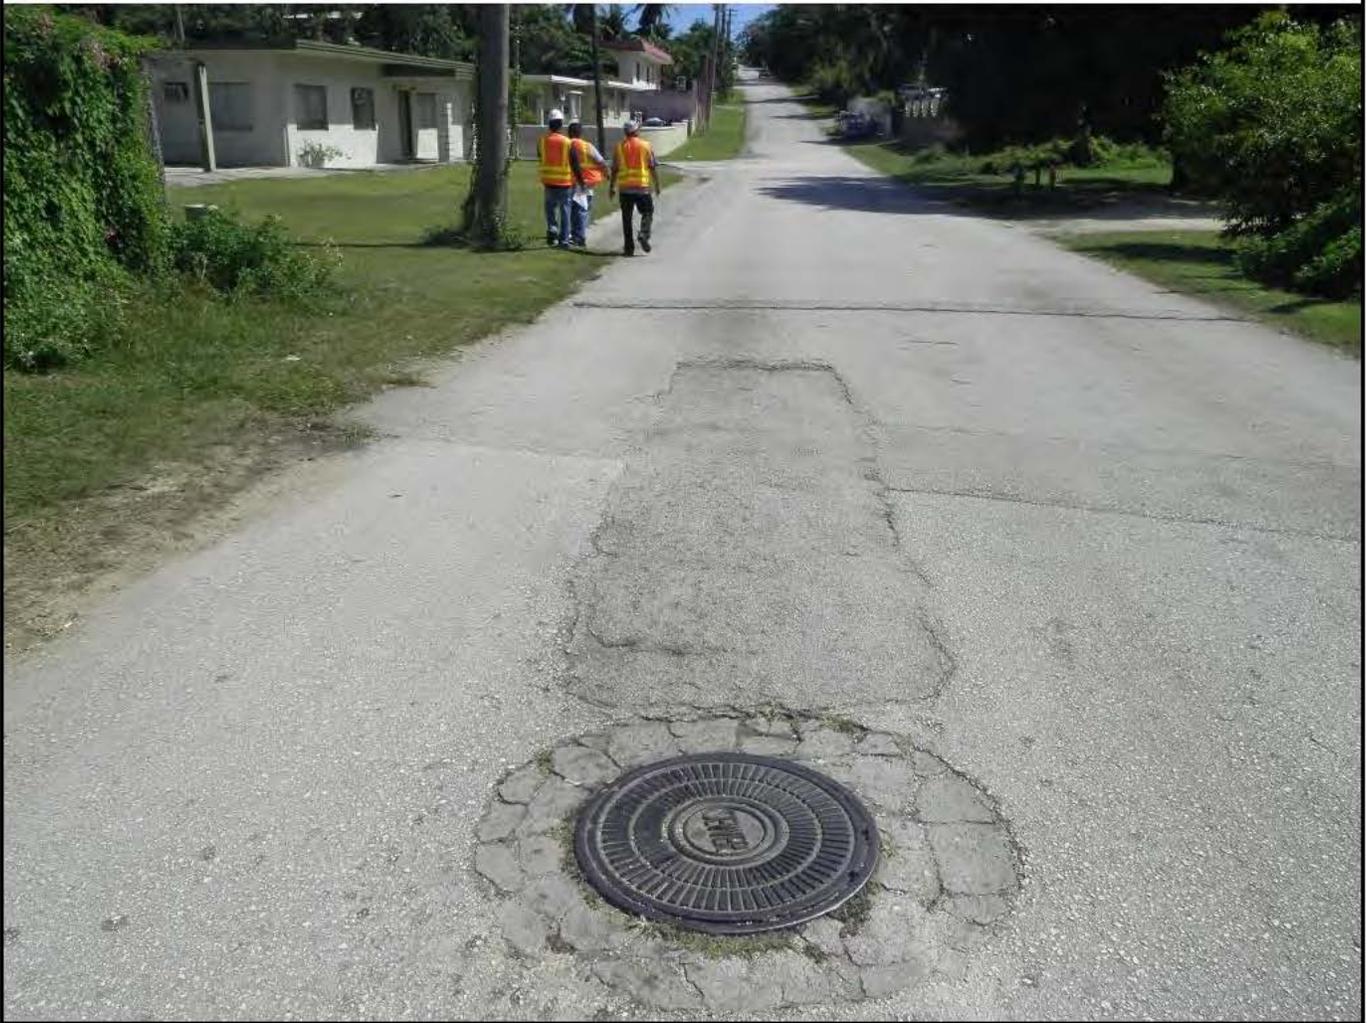
File Name: RIMG0066.JPG

Title	Guam Waterworks Authority (VP0989)
Subject	CWA Collection System
Date Time Stamp	4/30/2012 10:02:18 AM
Photographer	D. Vanlerberghe
Description	Manhole near Agana Heights ponding basin
